# **Scarisbrick Park Conservation Area**

## **Conservation Area Appraisal**

**September 2001**

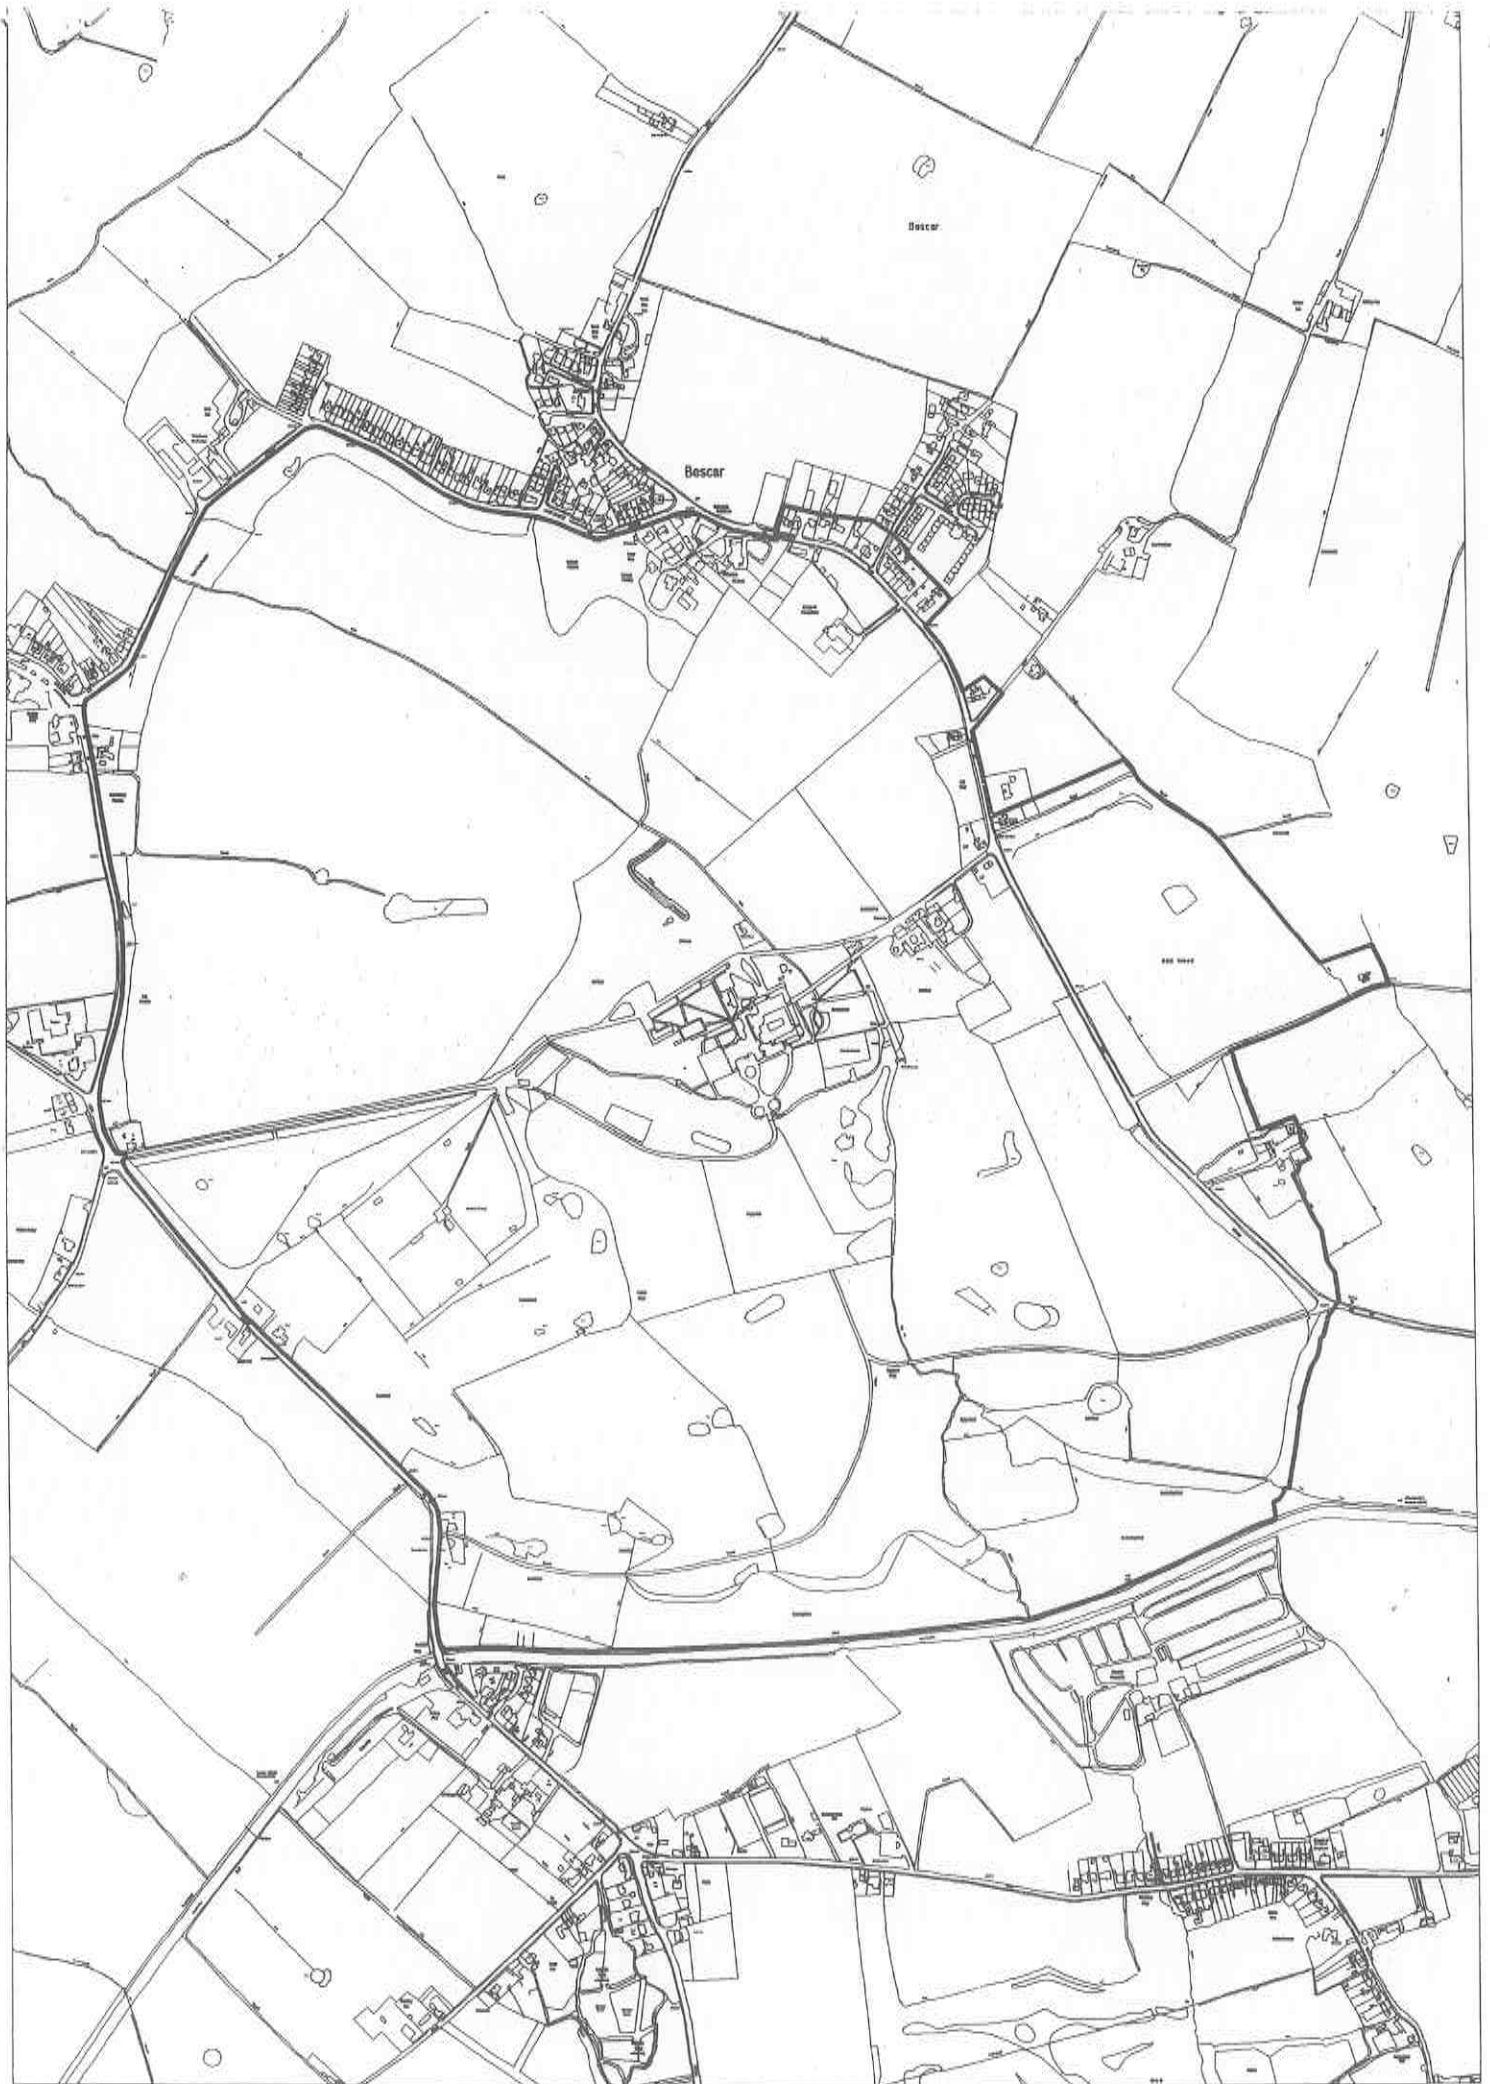
The map below shows the current boundary of the conservation area.

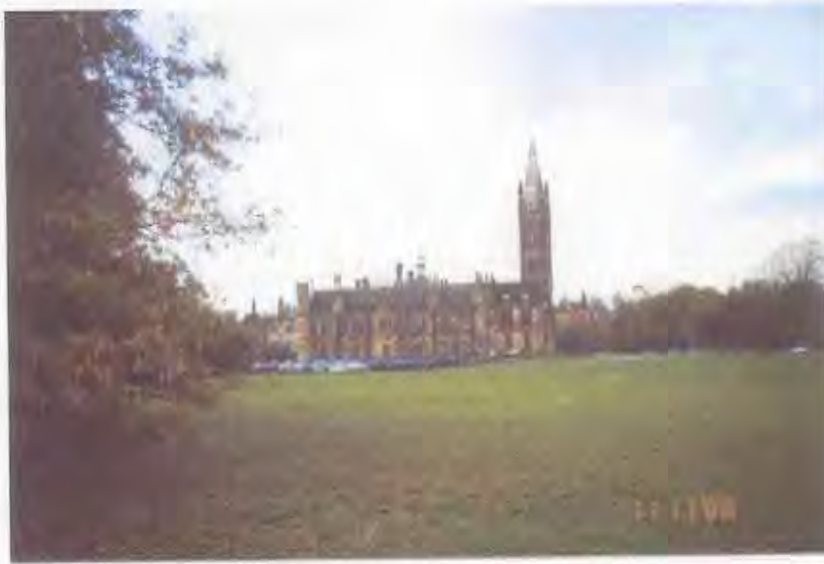
The Hall is the principal building in the Park, of gothic style and is the work of AWN Pugin and his son EW Pugin. Pugin senior worked on the house 1830-45 and his son was commissioned by Lady Anne Scarisbrick from 1861. The West Wing was modernised by Pugin and forms a cross wing to the Great Hall. The East Wing was added by EW Pugin who also pulled down his fathers clock tower and replaced it with the 50m high tower we see today - clearly the Hall's most dominant feature and indeed the Parkland's. There are gates 100m south of the Hall which are listed Grade II structures, dated 1870, and these were probably installed by the Casteja family replacing gates designed by Pugin which were moved to Bescar Lodge. A detailed architectural description of the including important internal features Hall is in Pevsner's North Lancashire (1969).

Scarisbrick Hall is without doubt the most significant building within the conservation area. Indeed it is one of only two secular Grade I listed buildings in West Lancashire and is of great importance and perhaps “the best Victorian House in Lancashire” (Robinson). It was placed on the statutory list in 1963.

It has long been known that the roof of Scarisbrick Hall is defective because of its age and complexity. The ingress of water has resulted in extensive fungal decay. It is essential that the owners and the appropriate public organisations work together to ensure the proper preservation of the building.

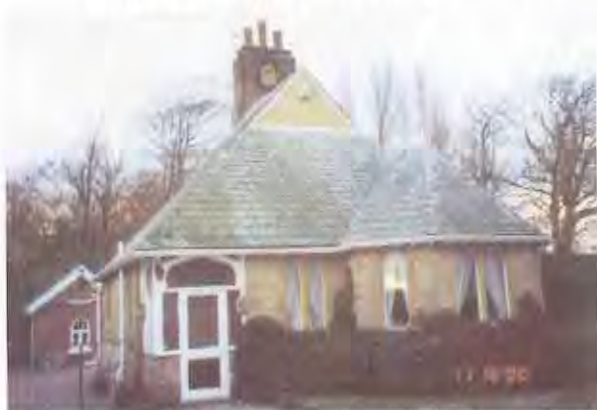
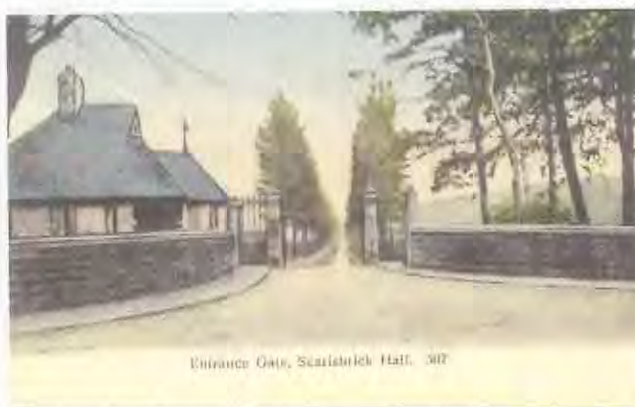
Entrance Gate, Scarisbrick Hall. 307

The Lodges are particularly important as they represent visible landmarks of the Scarisbrick Hall and Park from the main roads on the edges of the conservation area. They mark the historic entrances in to the Park via the main driveways and were constructed at different times. The main driveway which now serves the Hall (now school) is straight and is framed by a depleted avenue of trees and metal estate fencing on the north side which is in need of some maintenance. Within the fence are also posts where a gate originally stood serving a track leading to the feeding shelter in the middle of the field to the north. This driveway off Southport Road leads from Pine Lodge dated 1902, although a lodge in this location is depicted on the 1892 plan. Pine Lodge is constructed of buff sandstone with ashlar dressings, and has a Westmorland Green Slate roof. Unfortunately, one of the gate posts, and the gates themselves are missing.

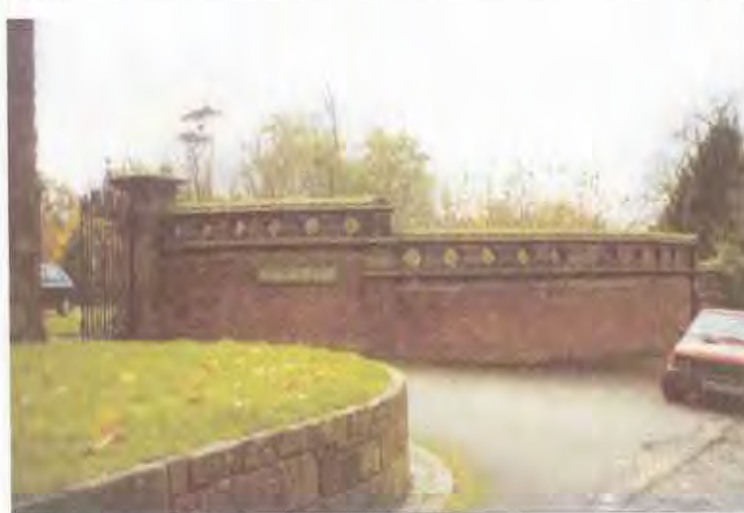
The historic farm buildings at Scarisbrick Park Farm, have been converted into dwellings and are located east of the Hall. This complex consists of Mallard Hey, a good example of a 1960's country house in brick, the former farmhouse and a number of former farm buildings, around a former farmyard. It is believed that the gates to Mallard Hey are those which were formerly in the gateway 100m south of the Hall.

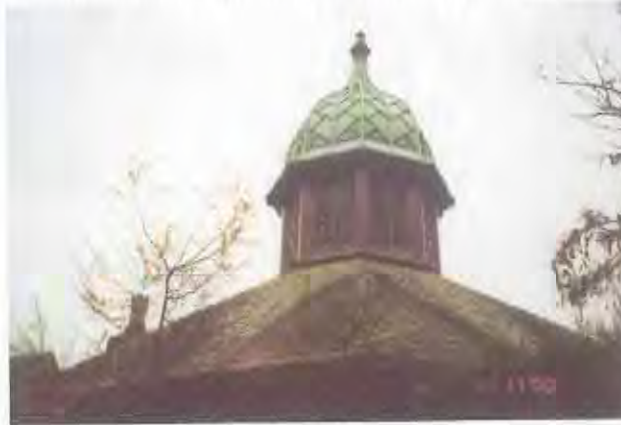
Partway down the drive from Hall Road is a late 19<sup>th</sup> Century dairy with a glazed gothic lantern turret and ribbed copper dome which for a time was used as a Mausoleum. This was almost demolished in the early 1970's but is now a private dwelling surrounded by suburban conifer trees, which provide privacy, but are out of keeping with the character of the area.

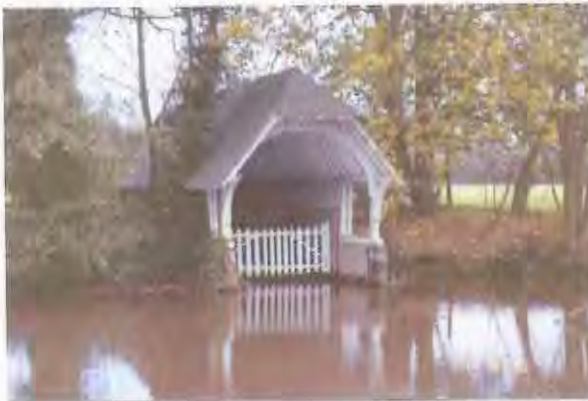
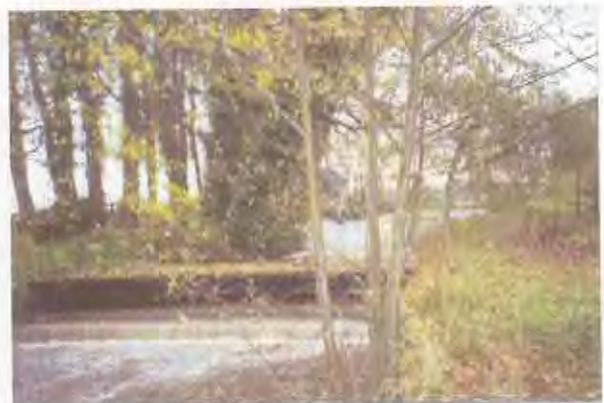
The boathouse is constructed of timber on a stone plinth and is situated in the top north-west corner of the lake east of the tennis courts and where the brook continues north around the stables. The structure is not listed but is an important and attractive structure in the Park which should be retained and maintained. The photograph shows the boathouse surrounded by trees and shrubbery, the reflection in the water is very picturesque. Just to the north of the boathouse is a large weir followed by a series of smaller ones which were designed to evoke the senses and compliment the garden experience. They add noise and movement and interest into the serene and tranquil landscape.

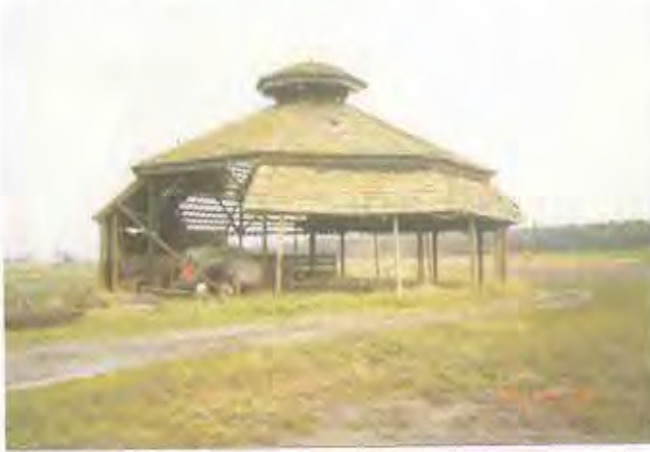
In the centre of the north-west quarter of the Parkland is an octagonal iron-framed feeding shelter (Grade II) built in the late 19<sup>th</sup> Century. The structure is very ornate for its intended use but was designed as an eye-catcher because it is highly visible from the main driveway up to the Hall. The Shelter originally stood at the intersection of 4 fields with radiating fences which enabled fields to be used separately more than likely for horses and cattle. Evidence from the 1892 map suggests that the two southern fields were run together (RCHME 1997). This field

system was not in place in 1850 but was set in place in the late 19<sup>th</sup> Century. The animal shelter now has permission for use as a dwelling, the principle of which was granted at appeal but it is in poor condition and in urgent need of repair.

5. Poor planning decisions such as consent to convert the animal feeding shelter to residential use, granted on appeal.
6. Inadequate maintenance of Park boundary walls.

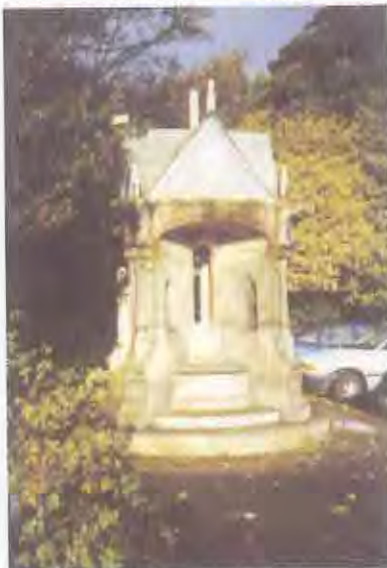
### Statuary and garden furniture

Much of the statuary and garden furniture was sold off in 1963 which is very unfortunate. They were located mainly around the formal pleasure gardens and entrance to the Hall and old pictures and postcards reveal something of the type of statuary which was in place. West of the car park adjoining the Hall there is still a gabled garden stone seat designed by Pugin in 1836. It is designed and positioned to allow views from all sides across the grounds. Again not listed, this is an integral part of the pleasure gardens and should remain in situ.

The photographs show students of St Katherine's College 'draped' over the statues around the gardens, in the late 1950's and this is the only evidence available at present of the statues at Scarisbrick.

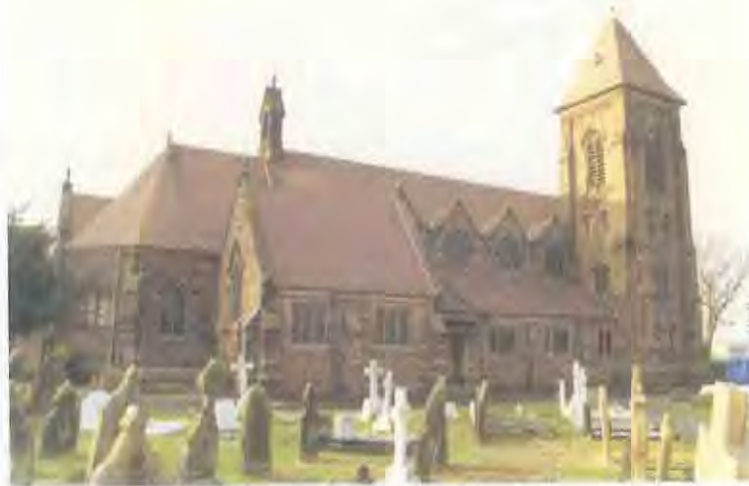
#### St Elizabeth's Roman Catholic Church, Bescar Brow

The Church is located at the northern edge of the conservation area on the site of the former chapel in the middle of Bescar Village. Built in 1888 by Pugin and Pugin in rock-faced red sandstone and a red tiled roof the Church is a very impressive feature. At the south gable is a memorial to Eliza, Margaret de Blandos Scarisbrick, Marchioness de Casteja who died in 1878 (Lady Anne Scarisbrick's daughter).

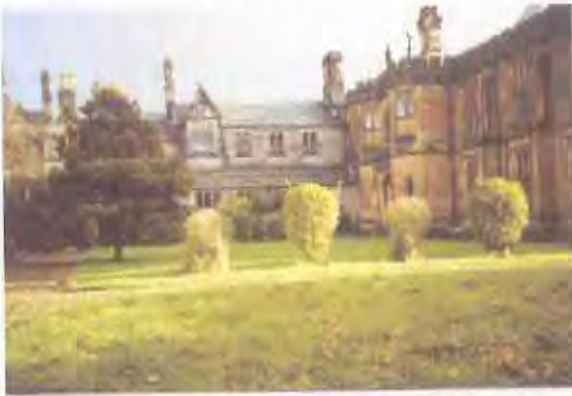
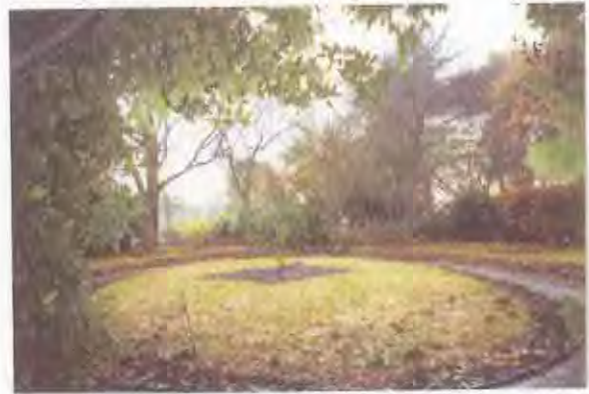
The pleasure gardens from the 19<sup>th</sup> Century are located in front of the Hall in a symmetrical arrangement of circular and curvilinear stone-edged beds which still survive, although now they have grass instead of flowers.

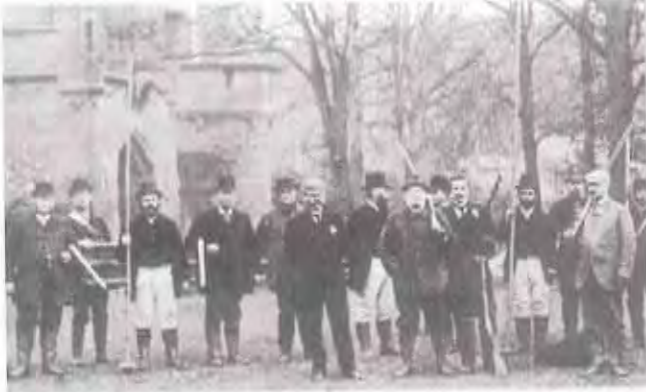
The picture of a shooting party with the Marquis de Casteja shows the former glasshouse in the background (source Duggan 1996).

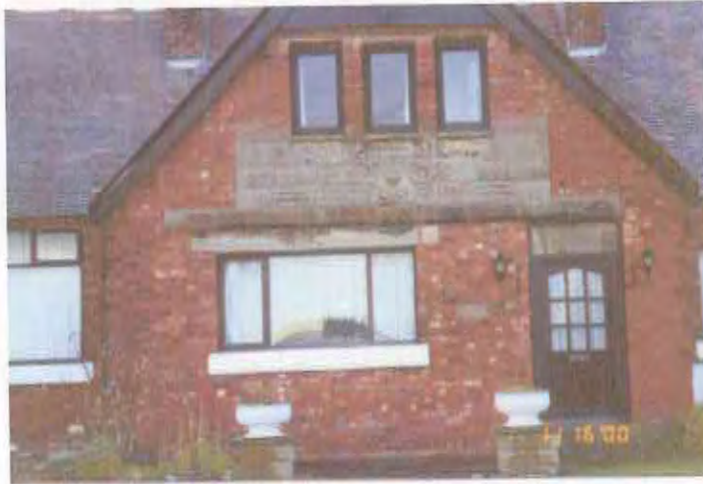
4. Harmful development to buildings within the conservation area such as lodges and almshouses such as porches, alterations to windows.
